# Manhole Inspection Summary

Manhole # S53I\_\_002MH

Insp Date: **5/28/08 8:38 AM**

**Location** Address: **3113 eastern ave**

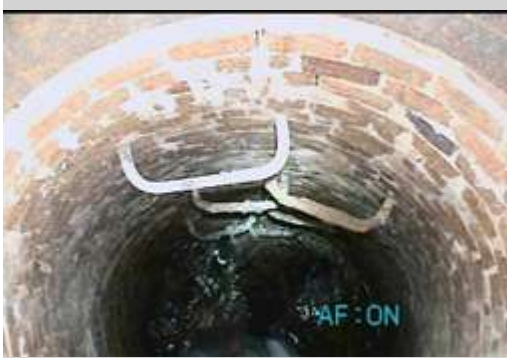
Defect 2

Count: **5** Missing: **0** ☒ **Corroded**

steps

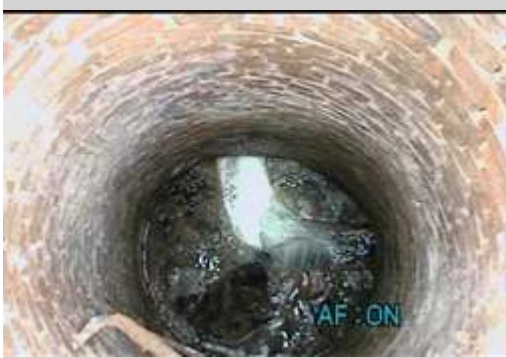
Defect 1

Condition: ☐ Sound ☐ Cracked ☐ Root Intrusion ☐ Deteriorated ☐ Leaks ☒ **Debris**

debris

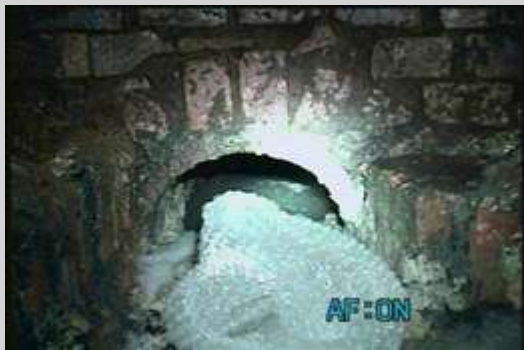
12 O'Clock Outflow

Deposits: ☐ None ☐ Mud ☐ Sludge ☒ **Debris** ☐ Grease

Silt Depth: **4** (in.) Deposits Extent: **Medium**

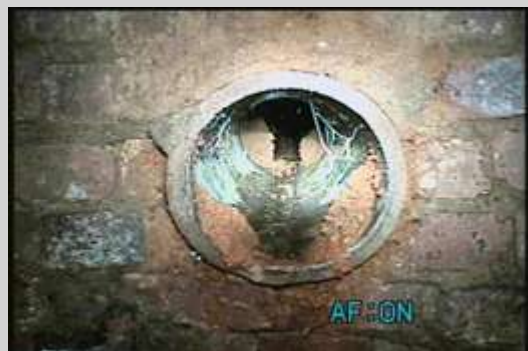
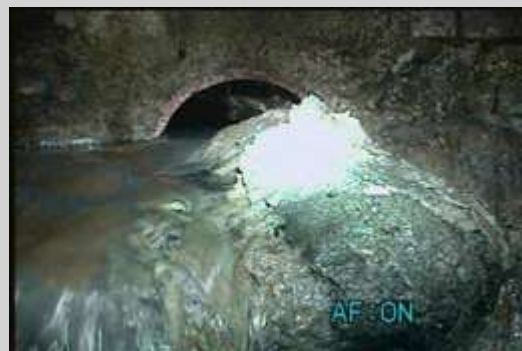
7 O'Clock Inflow

Deposits: ☐ None ☐ Mud ☐ Sludge ☒ **Debris** ☐ Grease

Silt Depth: **5** (in.) Deposits Extent: **Heavy**

Drop: **Outside Direct**
